THE WORK ROLL SURFACE DAMAGING STUDY: A KEY FACTOR IN USING HSS ALLOYS IN HOT ROLLING

ABSTRACT

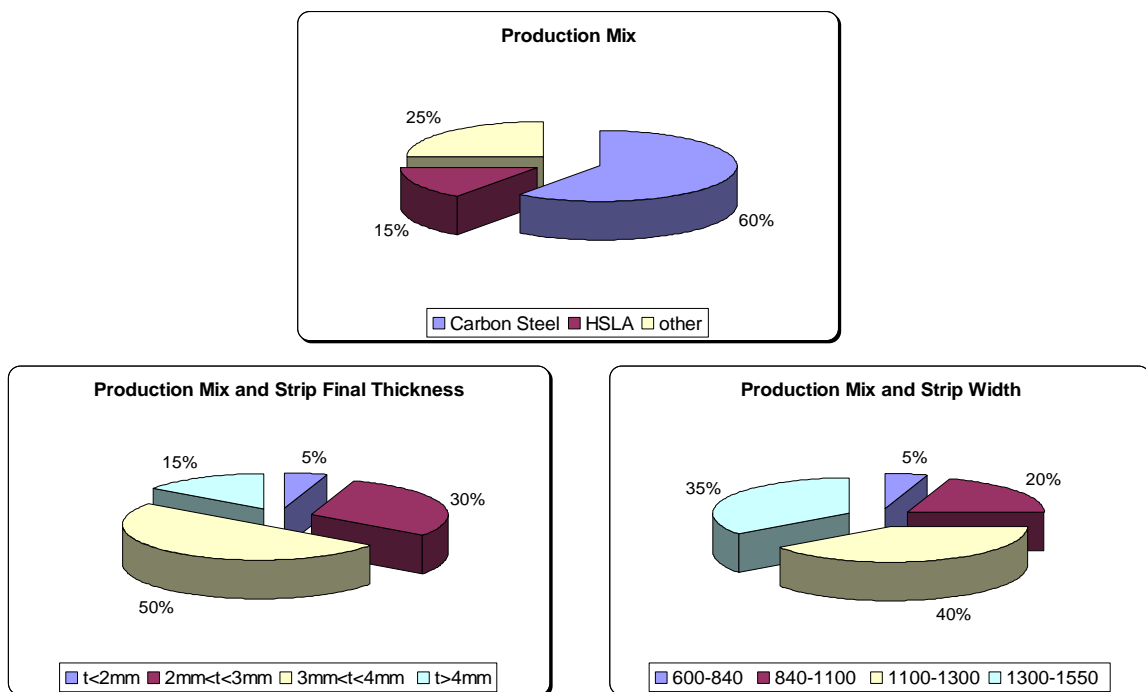
Figure 2 Mix of production of Siderar HSM

Typical yearly production is 2.7 Mton roughly divided in 60% Carbon steel, 15% HSLA and 25% among others families of steels. As far the production mix also in terms of thickness and width of rolled product see graphics in Fig.2.

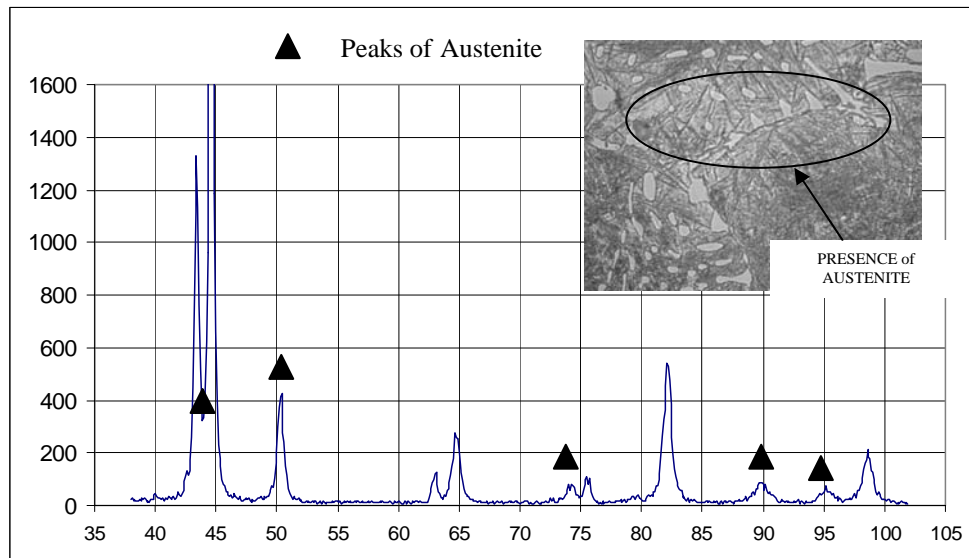
Figure 5 XRD spectrum and microstructure of HSS with a 15% of retained austenite

Their main characteristic is the maintaining of the hardness at high temperature that permits to reduce wear during rolling. Their microstructure is characterized by the presence of different primary carbides dispersed in a tempered martensite matrix. In these steels, the presence of high percentages of carbides formers elements (Mo, V, Cr...) joined with the carbon content, permit the precipitation of a big amount of carbides different each other for shape and distribution in function of the relative balancing among the elements (Fig.3). The solidification of these steels is quite complex providing several eutectic reaction. In the last years the alloy design has been aided by the use of thermodynamic modelling, so that the composition can now be tailored to obtain microstructure meeting the needs of the specific application in the mill. (Fig.4). Over the carbides, a very important role is played by the martensitic matrix: this constituent, that fix the hot resistance of the material, must undergo the heavy rolling conditions without losing its own resistance characteristics. The iron matrix must contain precipitates (secondary carbides) that permit it to limit the degeneration of its properties; the presence of these precipitates depends by the chemical content but also by the heat treatment that has a main role for the behaviour in rolling of these special steels. The heat treatment has another important goal in these steels: the elimination of retained austenite. In general this phase impairs the properties of the roll, i.e., reduce local hardness and causing embrittlement due to its transformation during service. An example of HSS with retained austenite is in Fig.5 (microstructure and XRD spectrum).

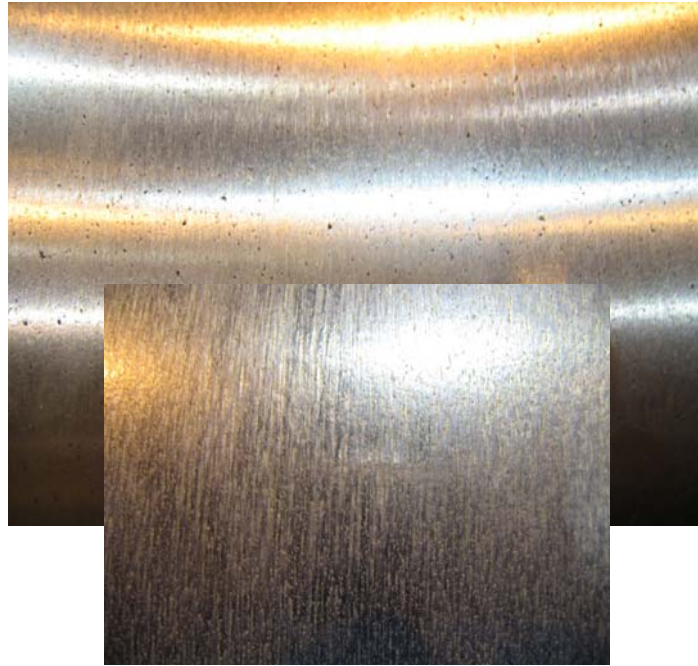
Figure 6 Pitting on the roll surface (Stand F1 after 10000 ton)

Pitting is a localized form of degradation characterized by detachment of material usually distributed throughout the entire surface of the roll barrel in contact with the strip (pits on the barrel of the roll); the phenomena is higher at the centre of the barrel where thermal stresses are bigger. Micro detachments can extend over a surface area of 2mm² and a maximum depth of 0.5mm. This problem is strictly connected with the thermal cycle undergone by the roll, but mechanical and microstructural characteristics of the roll can partially limit it. The Figure 6 shows a roll surface with pitting. The image in foreground is the roll surface before grinding while in the background there is the residual pitting after a redressing of 0.25mm.

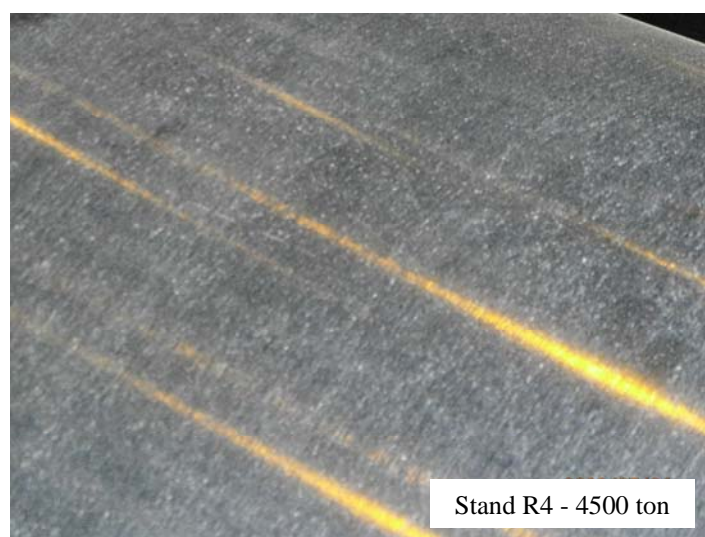
Figure 11 Detail of the roll surface

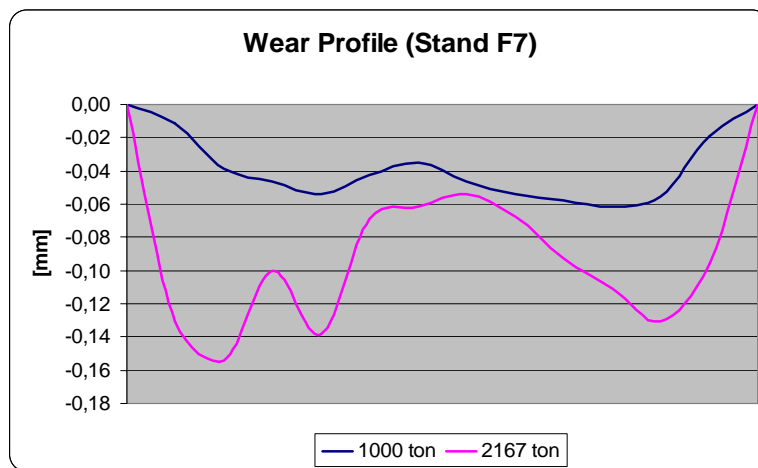
Figure 13 Examples of wear profiles in stand F7

In Figure 13 there is an example of wear profile (stand F7).

The analysis splitting data between different grades of HSS doesn't outline any clear trend (Tab.4). In laboratory, the grade B shows a superior wear resistance respect to grade A. The data examination only considering the wear confirms this aspect: the grade B shows a lower consumption of about 10% (Tab.5). The calculation of the wear is made in the middle of the roll barrel. This method to calculate the wear isn't the best but it allows a good estimation. Many times the wear profile is like in Fig. 13 so this approach can underestimate the wear.
